COUNTERACTING

CORROSION

COMPLICATIONS

**Caroline A. Fisher, Bryan Karasek,
Rick Kimpel and Zachary Phillips,
Aegion Coating Services, USA,** highlight
the developments in prevention coatings
for corrosion in pipeline projects.

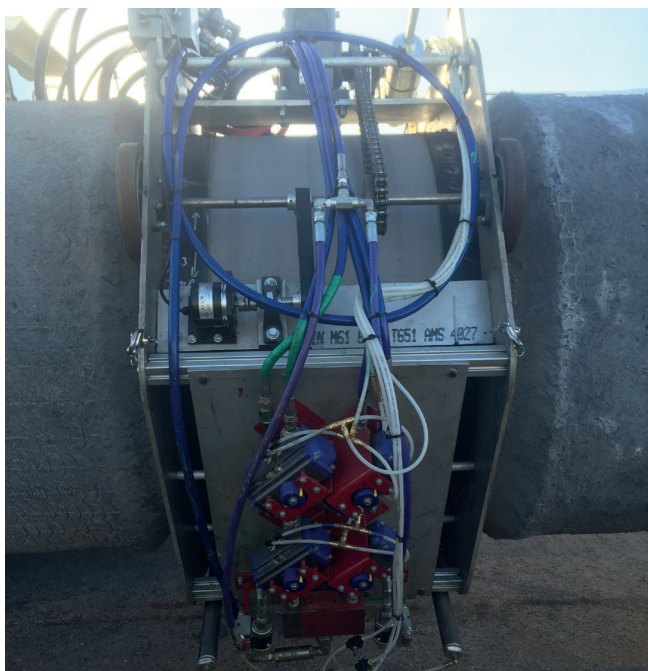
Figure 1. This automated liquid coating system reaps environmental benefits with an overspray recovery box that captures approximately 95 - 99% of fugitive emissions.

ACS brought customised equipment to the project, including CCSI induction heating rigs, an external automated liquid coating ring, and CRTS robotic cleaning, coating and inspection equipment for the internal corrosion prevention process. The crews found it essential to work closely to achieve the highest quality internal and external coating results for the customer.

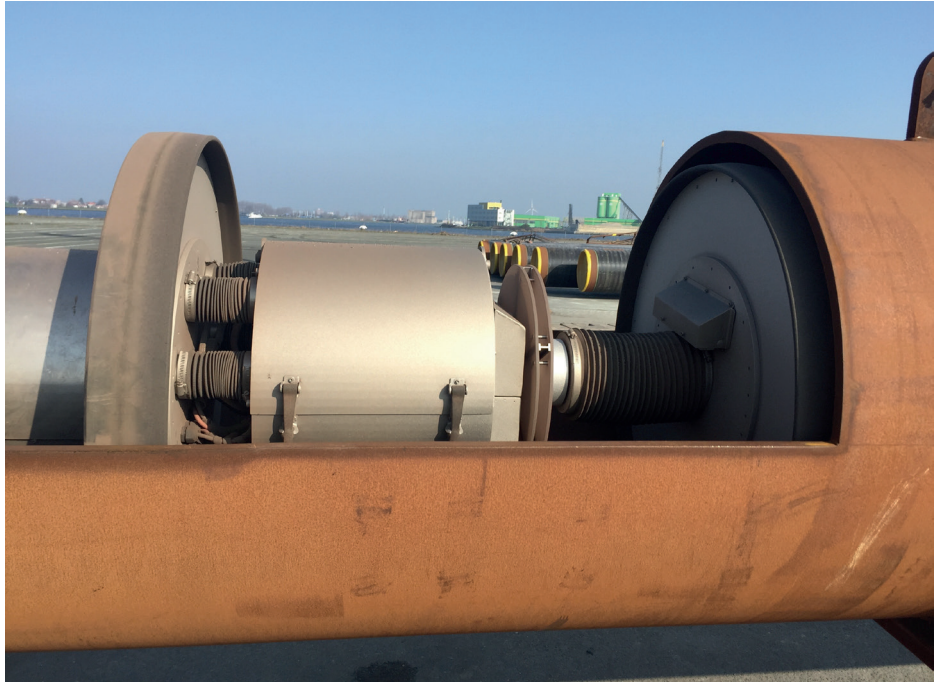
Figure 2. The robotic cleaner ensures a surface profile that the coating will adhere to, providing seamless corrosion prevention.

A crucial factor before coating is prepping the pipe's field joint surfaces, including eliminating electrolytes (inside and out) and creating a surface profile. The surface profile determines whether or not the coatings will adhere properly. For an internal field joint coating, the cleaning process ensures the weld meets NACE 2 (SSPC-SP10) specifications after welding/inspection, and creates a profile on the fresh weld metal. ACS used CRTS line-up cameras to locate each internal field joint, and then robotically cleaned it with abrasive grit. The vacuum unit then reclaimed the grit for recycling, and the onboard camera helped the operator ensure all of the abrasive grit was removed.

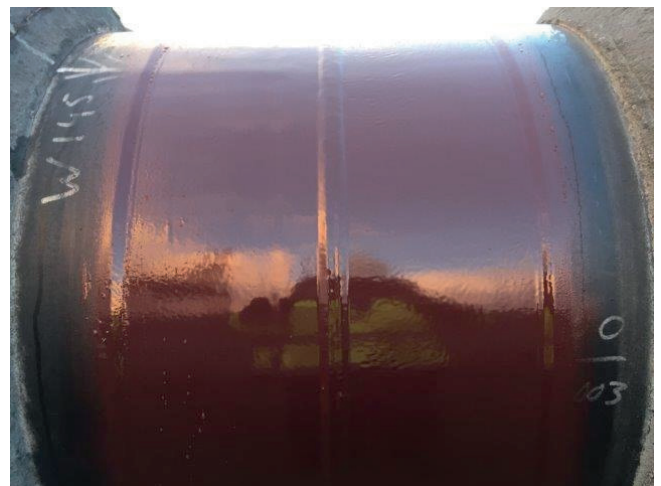
Figure 3. Coating external field joints assures seamless corrosion prevention.

The external field joint blasting was performed using the CCSI external blast ring and blast recovery system (BRS) units. These units also incorporate recycling devices to help ensure there are no impurities left on the welded surfaces. The BRS units also reduce customer costs by recycling the blast media and reusing it on the next field joint.
